SANDRINGHAM BEACH AND GARDENS MASTERPLAN

Thompson Berrill Landscape Design P/L
May 2017

INTRODUCTION

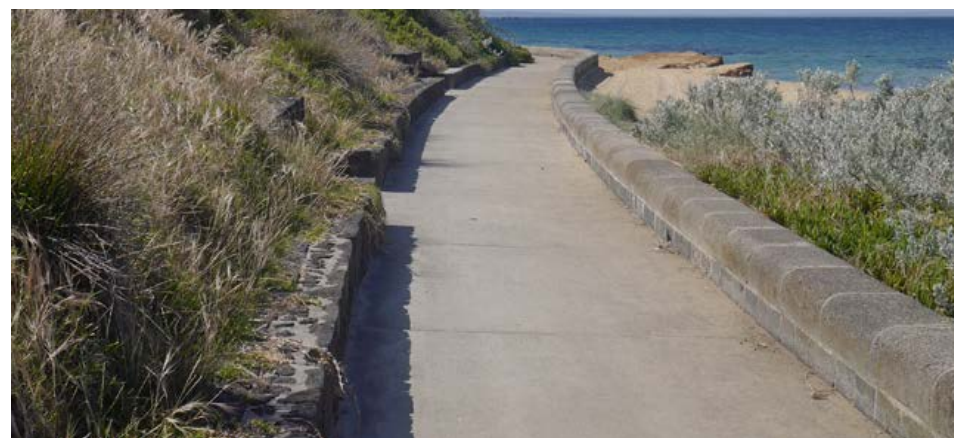
Photo 6: Sandringham sea wall

During the Great Depression councils were encouraged to employ local men on relief work (also known as 'Sussos'). In the 1930's Sandringham City Council (recently separated from the Parish of Moorabbin) decided on a project to protect local beaches from further erosion by building bluestone walls and rock facings. The stones in this area and other seawalls on the foreshore at Brighton and Black Rock were taken from the outer walls of the Old Melbourne Gaol.

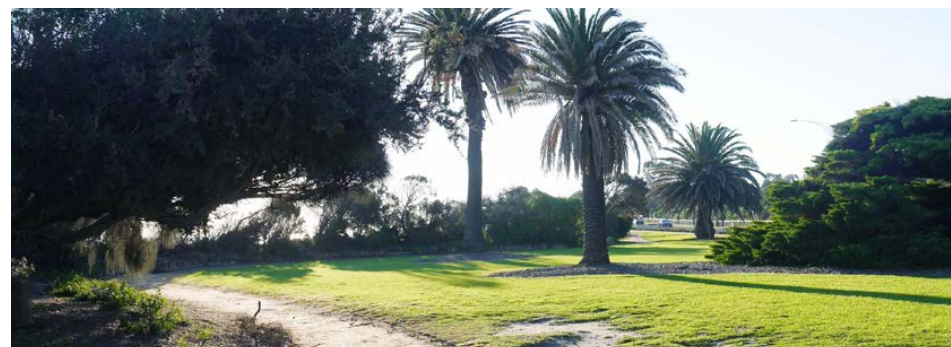
Photo 12: Sandringham Gardens grassed area

The formal lawns at Sandringham Gardens, shaped by the concrete edged symmetrical path network are an important part of the historic formal landscape character of the park. The gardens lawns were once irrigated however they have been degraded by a combination of drought, poor drainage and compaction from maintenance vehicles in many areas. Proposed works include:

- Rationalise rubbish bin collection points to reduce impacts from maintenance vehicles. (H)
- Top dress the unsealed paths, reinstate concrete path edging, improve drainage and returf kikuyu lawns through the gardens. (H)
- Investigate option for storm water harvesting to enable sustainable reactivation of irrigation systems through the formal gardens. (L)

At Sandringham Gardens regular ongoing pruning of the historic Cypress Trees is required to maintain clearance on the Bay Trail. In this area pedestrians typically use the various other unsealed path options through the gardens so there is less conflict with cyclists and the trees need to be carefully pruned to avoid die back. (O) Refer photo 12.

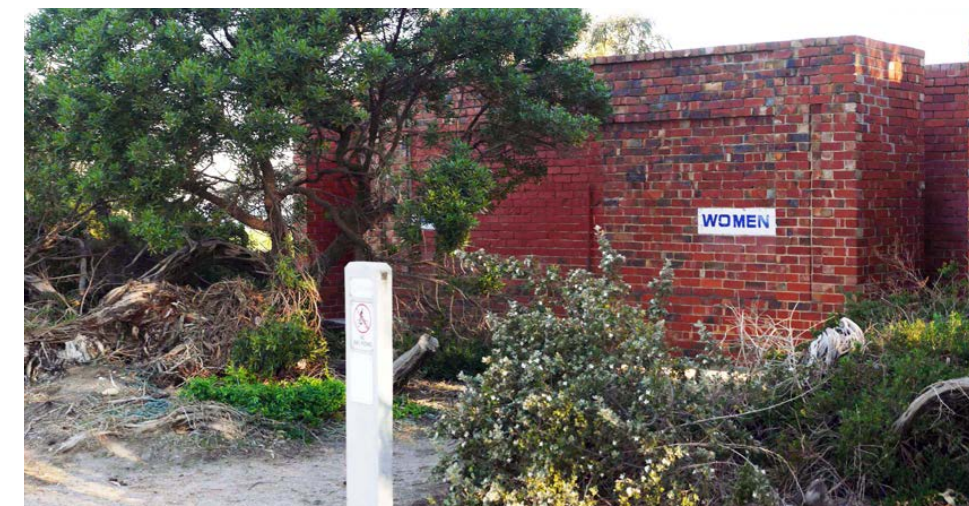
Photo 13: Southey Street Toilets

The older brick public toilet on the foreshore at Southey Street is to be replaced, the existing facility does not meet current accessibility standards and has been ranked within the top ten for major upgrade/replacement in 'The Bayside Public Toilet Strategy (2012)'. The existing red brick structure will be demolished and a new facility built that will provide a higher standard of compliance relating to safe design guidelines for public toilets, accessibility and the building code. The new facility will have safe designed cubicles, interiors that are bright, airy and hygienic, anti graffiti materials, accessible design and a compact footprint. One tree is proposed to be removed for sight lines to ensure those using the bay trail can enter and exit safely.

- Install signage within the B12 car park and at the pedestrian lights to alert visitors to the nearest public toilet at Southey Street. (H)
- Replace the Southey Street toilet to provide accessible cubicles within a contemporary facility at the same location. (H)
- Following upgrade establish a short sand coloured concrete path from the Bay Trail to the Southey Street toilets to improve all ability access. (H)
- Undertake weed control and revegetation around the existing SLSC toilet and beach shower using coastal indigenous species.(M)
- Continue ongoing management of vegetation to maintain clear sightlines for safety around all public toilet facilities. (O).

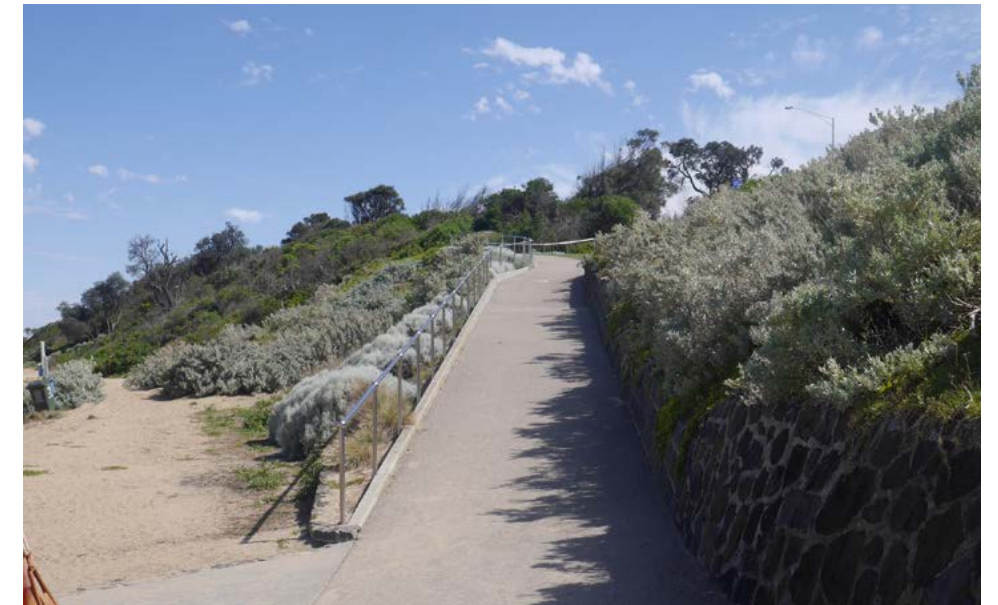
Photo 18: Sandringham Life Saving Club Ramp Access

Sealed asphalt emergency and maintenance vehicle access to the beach is via Sandringham Life Saving Club ramp and from the B11 Sims Street car park.

This 2.5m wide asphalt ramp provides emergency and maintenance vehicle access to the beach north of the Sandringham Life Saving Club and is used by pedestrians visiting the public toilet and beach from the B10 Abbott Street car park. The ramp grade is approx 1 in 10, with flat landings every 15m and a stainless steel handrail to one side. It is proposed to establish stainless steel handrail to the other side and new bike parking at beach level. (H) Refer photo 25.

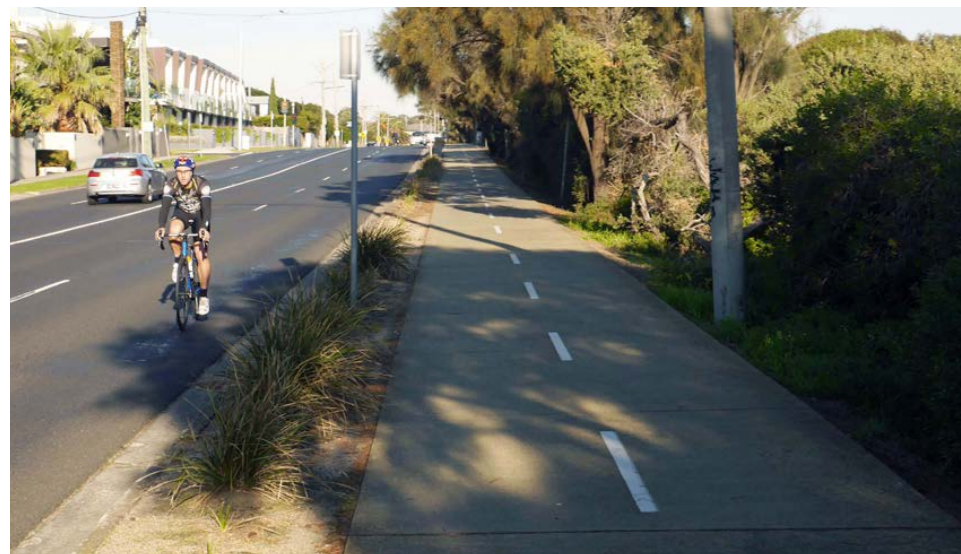
Photo 20: Beach Road and Bay Trail

The 2.5m wide Bay Trail provides continuous off road access for both pedestrians and cyclists travelling along Beach Road. Increasing use of the trail by cyclists and pedestrians may mean the entire path will eventually need to be widened to at least 3.0m in accordance with current standards.

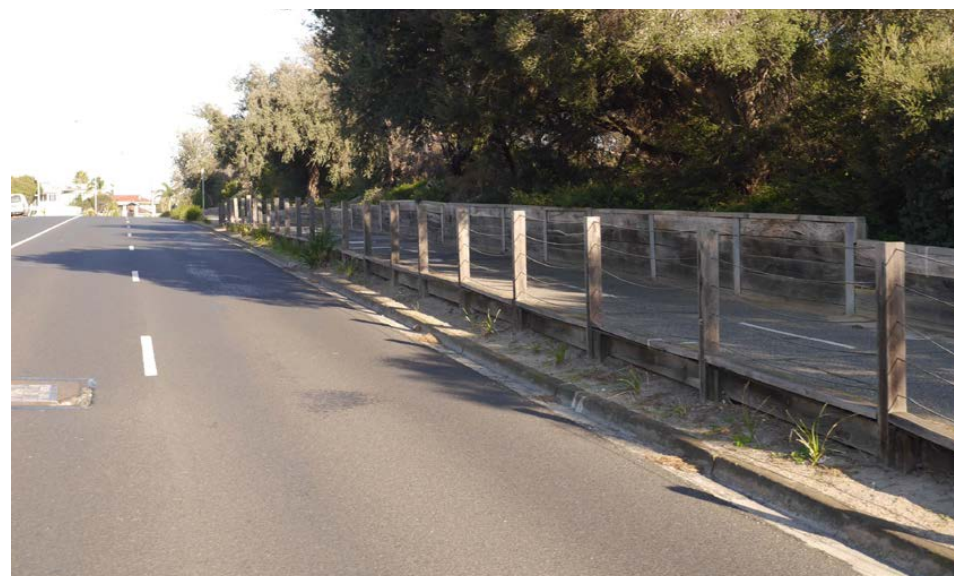
Photo 21: Bay Trail - Boardwalk at end of Red Bluff Street.

Timber boardwalk and retaining wall section south of Red Bluff Street section is only 2.5m wide and is used by both cyclists and as part of the Coast Walking Path as there is no alternative access. When replacement is required investigate options to widen the path to meet current standards while minimising impacts on vegetation. (M) Refer Photo 21.

- 5 Replace and widen the timber boardwalk and retaining wall section south of Red Bluff Street. (M)
- 6 Widen the path at the pedestrian crossing point at the traffic lights between Masfield Avenue and Royal Avenue. (L)
- 7 Investigate widening of the cantilevered boardwalk section of Harold Street and Edward Street. (L)

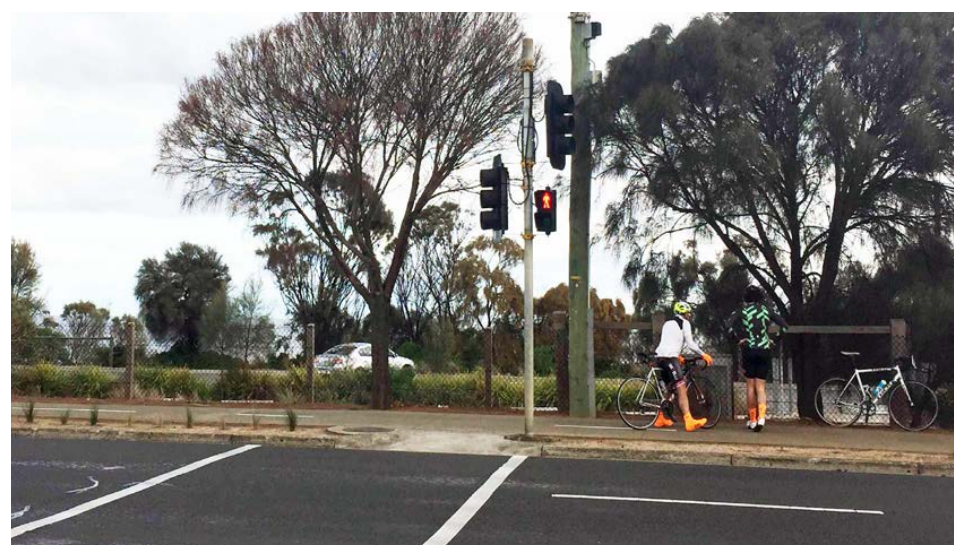
Photo 22: Bay Trail - Pedestrian crossing lights at B12 Carpark

B11 and B12 car park entry/exit points require ongoing vegetation management to maintain clear sight lines. (O) Refer photo 22.

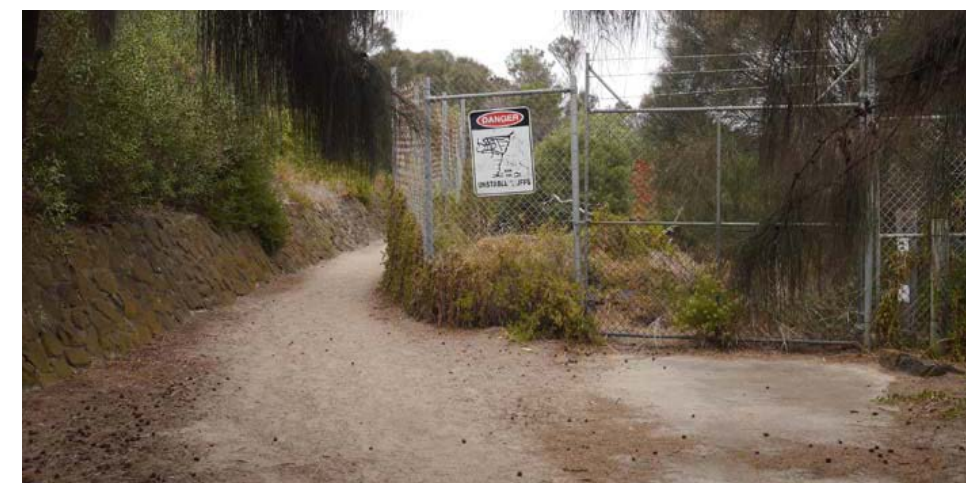
Photo 24: Existing fencing at Royal Avenue.

- Remove chain mesh construction fencing and replace with timber post and cable fencing to restrict access to the former beach access ramp. (H) refer photo 24.

- Remove all visible debris from the former access ramp to assist continued recovery of Indigenous Coastal vegetation. (M) refer photo 24.
- Retain fencing only to the coast side of the path and use natural cut Tea-tree logs to define the trail alignment on the unfenced side. (H)

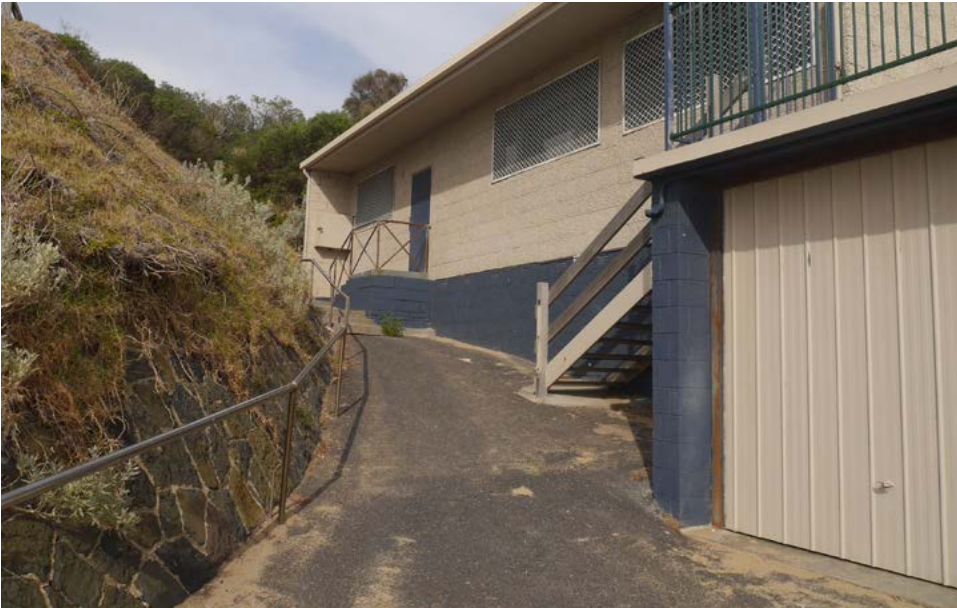
Photo 26: Sandringham Life Saving Club Stairs Ramp

This 1.8m wide asphalt ramp behind the building has short sections of bluestone stairs and handrail to one side. It provides the most direct access to the club for visitors parked on Beach Road and is sometimes used by club members at night. It is proposed to install a new stainless steel handrail and upgrade exterior lighting behind the SLSC. (M) Refer photo 26.

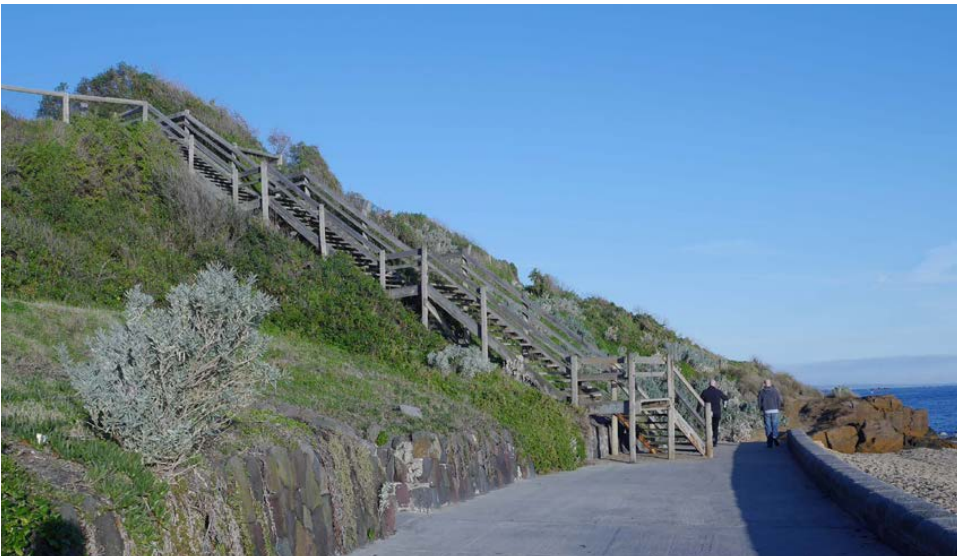
Photo 27: Bay Road Stairs

Established at the southern end of the sea wall path the stairs provide the most direct access to Sandringham Beach from the B11 car park, playground, picnic area and pedestrian crossing to the shops and railway station at Bay Road. The use of treated pine timber in this visually prominent location clashes with the predominant stone and concrete masonry character of the gardens. Despite ongoing maintenance the aging timber stairs will likely require complete replacement within 5 years. Refer photo 27.

- Consider replacing the existing timber stairs with a new set of stone/ concrete stairs set back into the bank to minimise visual impact, designed to match the existing character of the gardens. Subject to geotechnical investigation and impact on vegetation.
- Undertake revegetation of the former stairs site using low indigenous ground layer planting. (H) Refer Sandringham Gardens Detail Plan.

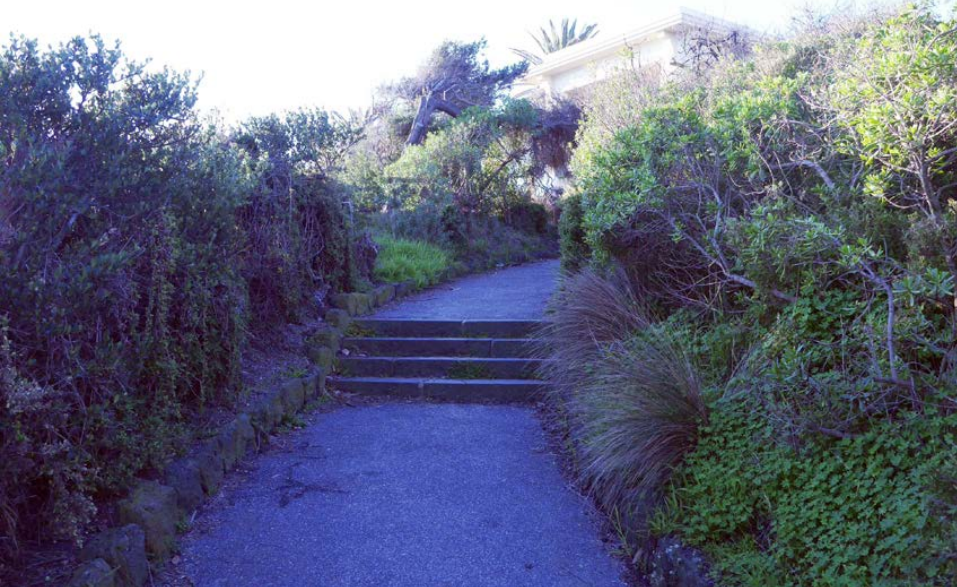
Photo 28: Rotunda Ramp

This 1.8m wide asphalt ramp has short sections of bluestone stairs and handrail to one side. The bluestone stairs link the rotunda down to the lower sea wall path. The ramp is typically used by visitors to the rotunda. It is proposed to install new stainless steel handrails to both sides. (L) Refer photo 28.

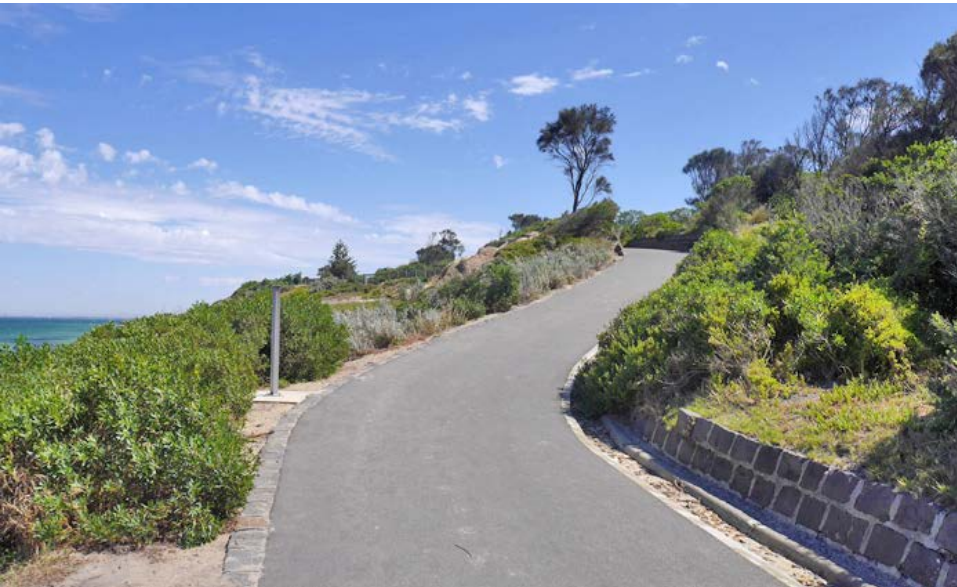
Photo 29: Sims Street Access Ramp

It is proposed to establish stainless steel handrails to AS1428 on both sides and investigate establishment of a beach shower and bike parking at beach level. (M) Refer photo 29.

- 9 Sims Street Access Ramp - Establish stainless steel handrails to AS1428 on both sides and investigate establishment of a beach shower and bike parking at beach level. (H)

| Item No. | Plan Ref | Action Description | Amount | Item | Rate | Cost | Priority | Agency Responsible for approval | Agency responsible for funding | Related Actions |
|---|---|---|---|---|---|---|---|---|---|---|
| 2.3 | 9 | Sims Street (B11 car park) beach access ramp. Establish stainless steel handrails to AS1428 on both sides. | 220 | lin.m | \$250 | \$55,000 | High | BCC | BCC | 7.1 |

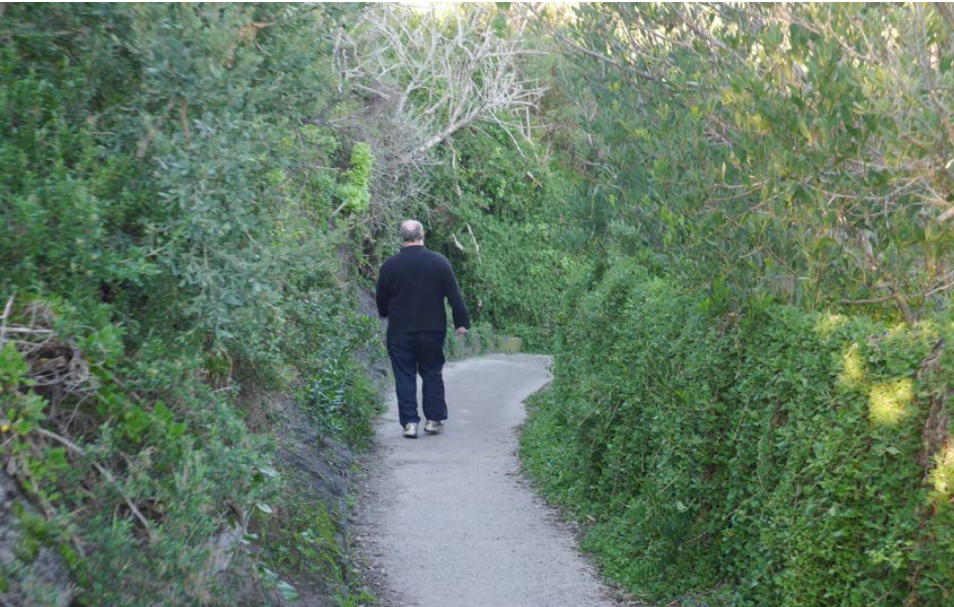
Photo 30: Coast Walking Path between Harold Street and Edward Street.

- Replace sections of log stairs using an all ability graded durable composite fibre mesh ramp backfilled with local granitic gravel/sand. (H)
- Establish a new handrail and advisory signage on the steep sealed path section between Harold Street and Edward Street. (M) Refer photo 30.

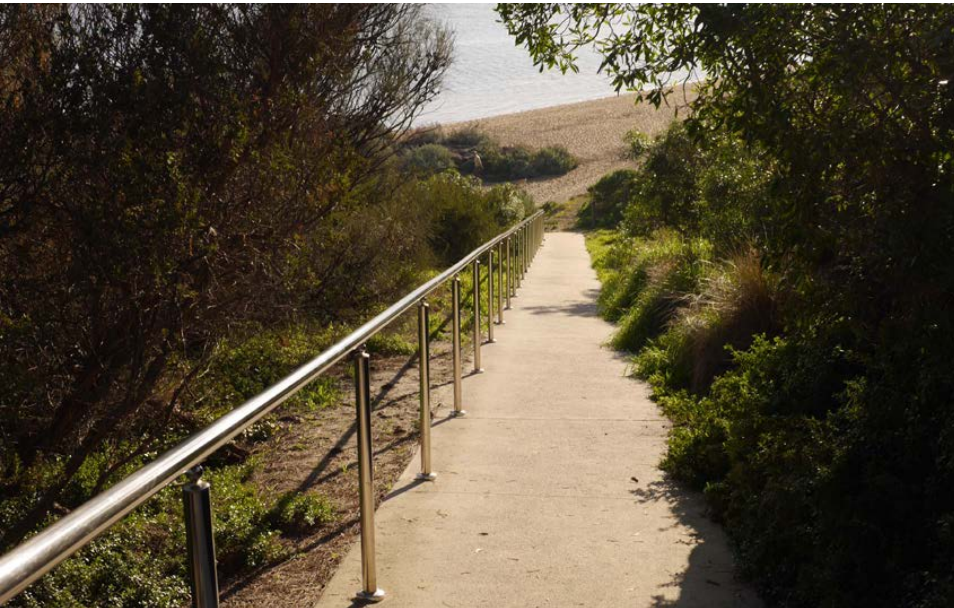
Photo 31: Southey Street Ramp

The steep concrete ramp was recently replaced after an older ramp, further south to Royal Avenue beach became unstable and was closed. The ramp is 1.5m wide with a handrail to one side. It is proposed to establish a handrail to the other side with a rest point and seat midway along the ramp and saw cuts in the concrete to increase grip. (L) Refer photo 31.

| Item No. | Plan Ref | Action Description | Amount | Item | Rate | Cost | Priority | Agency Responsible for approval | Agency responsible for funding | Related Actions |
|---|---|---|---|---|---|---|---|---|---|---|
| 2.6 | 10 | Southey Street access ramp. Widen the path to min1.5m, establish flat resting spots and install stainless steel handrails to AS14285 on both sides with additional saw cuts to the concrete to improve grip. | 1 | Item | | \$70,000 | High | BCC | BCC | |

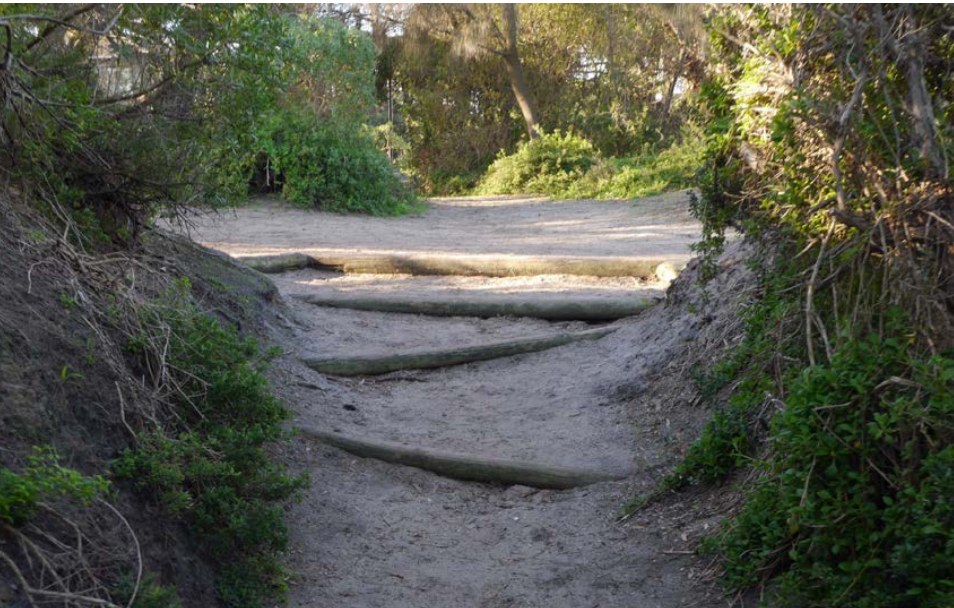
Photo 32: Top of Royal Avenue Stairs.

The long straight set of concrete stairs at the end of Royal Avenue are popular with fitness groups and personal trainers. Overland stormwater drainage has eroded the unsealed path at the top of the stairs.

It is proposed to remove the timber log steps and upgrade the unsealed path from Beach Road to the top of the stairs and replace the drinking fountain. (M) Refer photo 32.

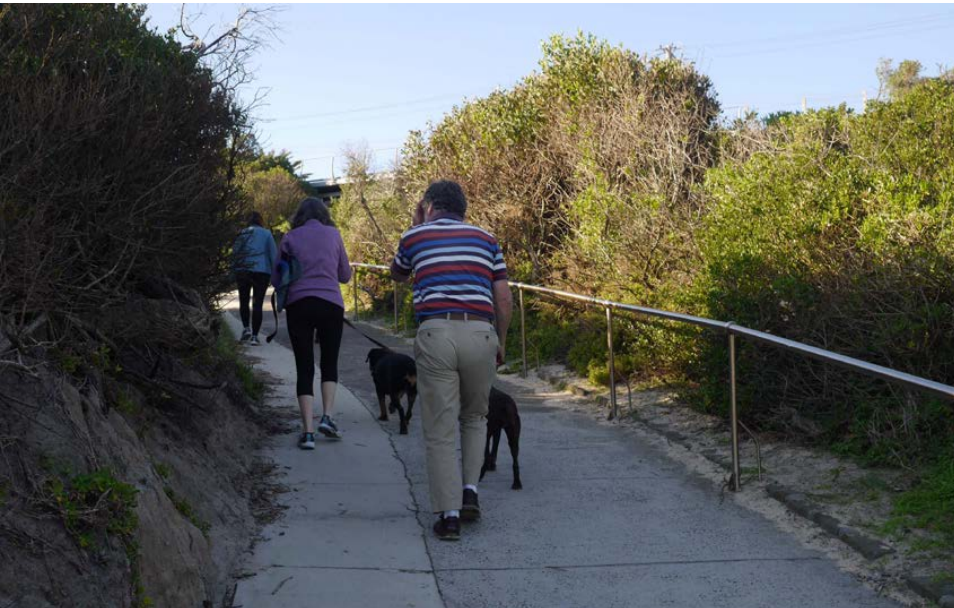
Photo 34: Edward Street Ramp

- Install warning and directional signage a beach level directing visitors to the ramp and indicating that there is no safe access via the beach to Half Moon Bay. (H)
- Resurface the existing ramp to improve access and establish two flat rest points with seats.
- Install new handrails to both sides. (M) Refer photo 35 and 36.

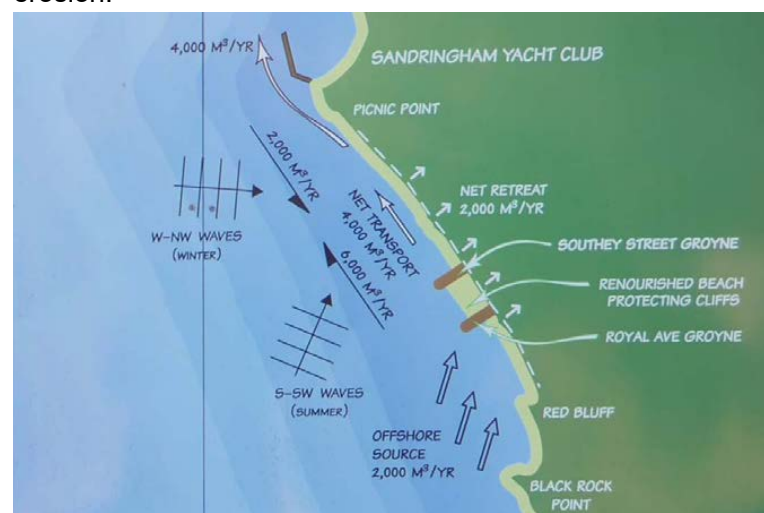
Figure 4. Coastal process at Sandringham Beach (DELWP)

The Royal Avenue and Southey Street beaches have been subject to ongoing erosion, especially over summer. Two rock groynes were established to improve retention of sand on the beach and to protect the Royal Avenue cliffs and infrastructure behind them. Despite this, some sections have been subject to ongoing erosion and storm bite. The Department of Environment Land Water and Planning (DELWP) is responsible for works and ongoing monitoring of the beaches. DELWP are currently investigating modifications for Southey Street and Royal Avenue groynes and renourishment of the existing beach in between. The Sandringham Foreshore Association also provide local input and assistance with monitoring of coastal conditions and erosion.

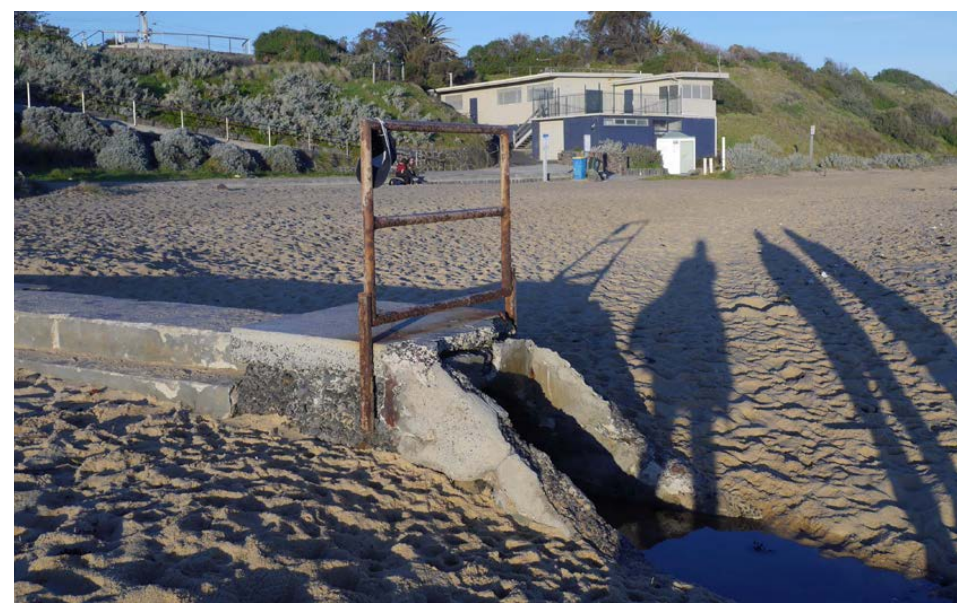
Photo 37: Sandringham Beach outfall

Liaise with Melbourne Water to undertake a detailed design investigation of measures to improve storm water quality prior to discharge at Sandringham Beach. (H) Works may include:

- Installation of an underground gross pollutant trap (GPT) within grass areas at the Crescent Gardens to remove litter and other particulate material larger than 5mm prior to discharge to the beach. All existing vegetation will be protected and the grass areas reinstated after completion of works.
- Installation of a new storm water surcharge pit with steel grille at beach level to release pressure during high flows and allow extension and lowering of the existing outfall to reduce obstruction on the beach. An internal weir system connected to an underground low flow diversion and sand infiltration system aligned along the edge of the beach/dune area could be used to remove nutrients and improve water quality.

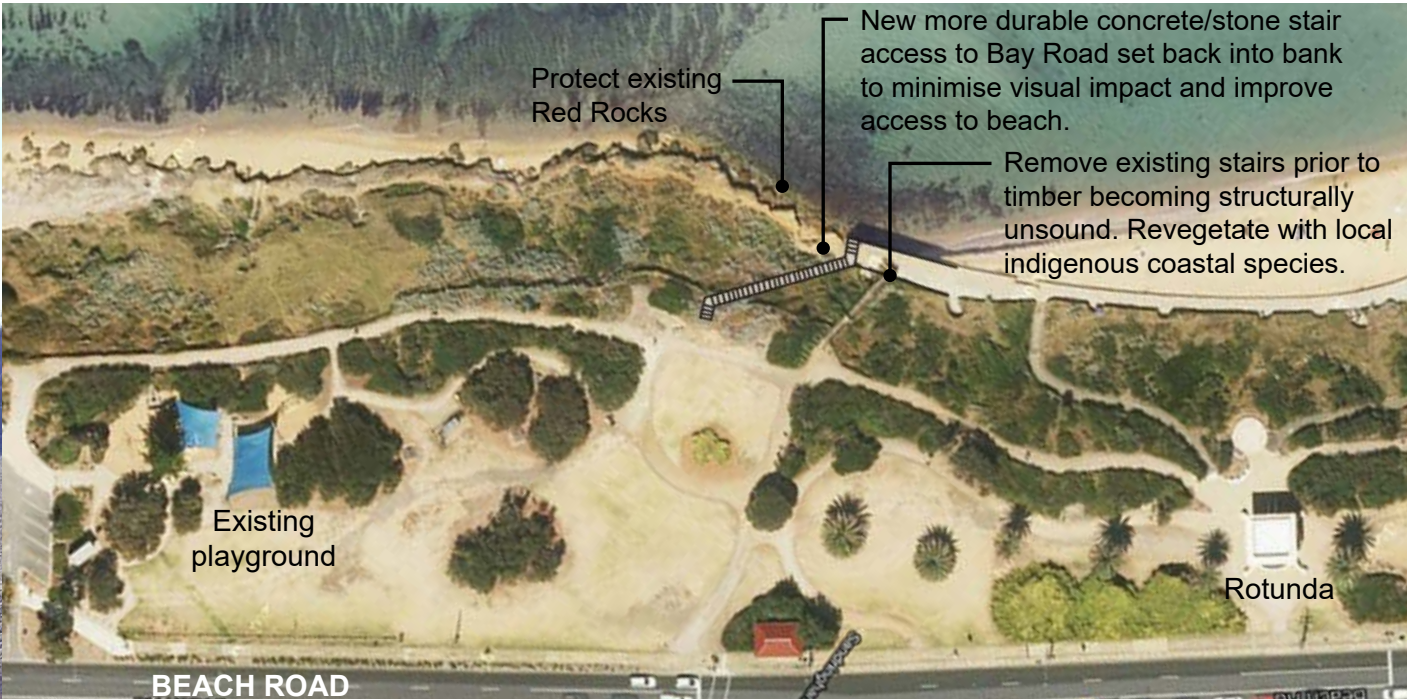
Figure 12. Proposed location of new stairs

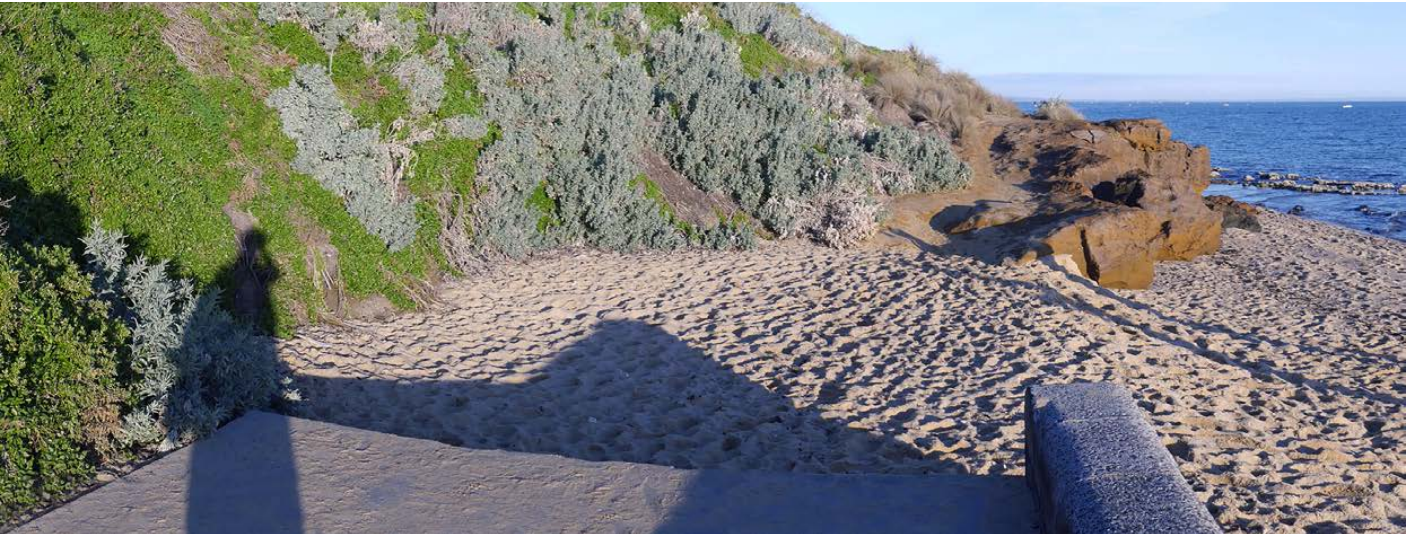
Photo 41. Proposed location of new stairs

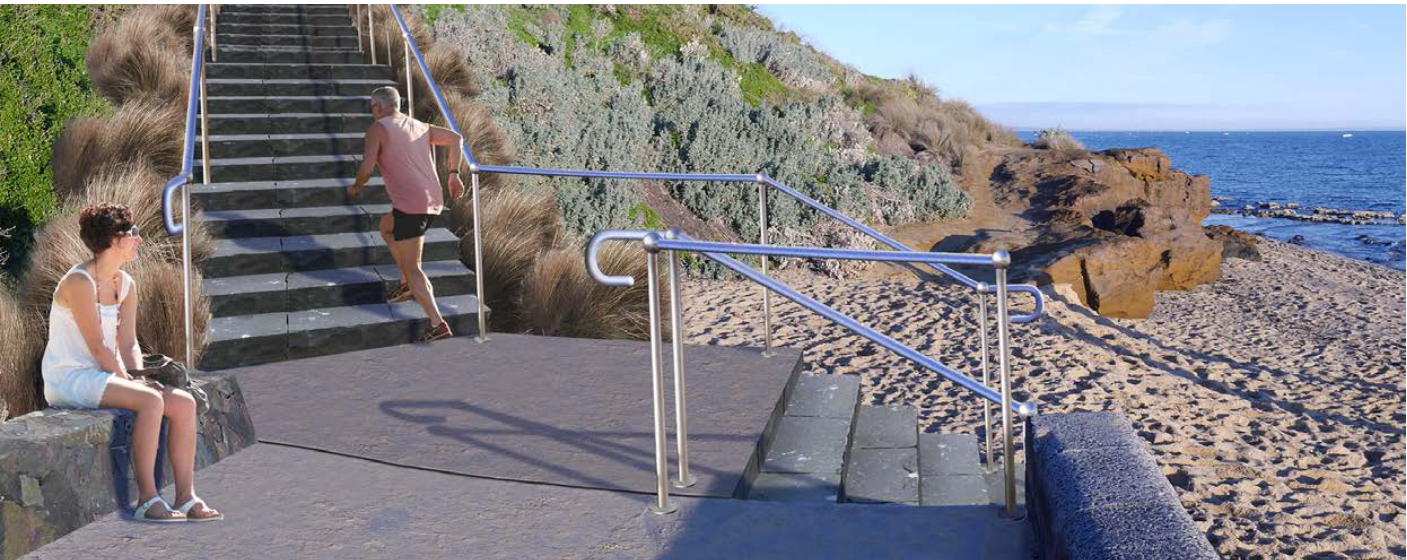
Figure 13. Artist impression of new stair system
